Feasibility of Rotor Fault Detection from a Fluid Dynamics Perspective

S. L. Robbins^{1†}, P. S. Heyns¹ and J. A. Heyns²

¹ *Centre for Asset Integrity Management, Department of Mechanical and Aeronautical Engineering, University of Pretoria, Pretoria, 0002, South Africa*

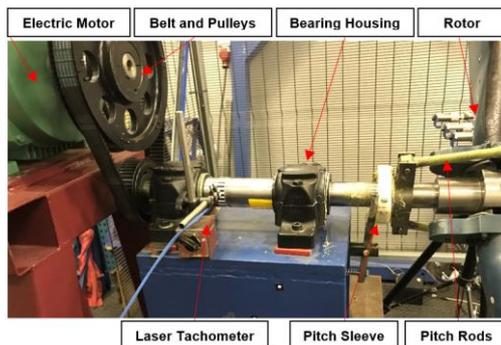
The helicopter tail rotor blade was attached to a shaft which had a sleeve to control both blade pitches uniformly. The shaft was positioned by two bearing houses. A 7.5 kW electric motor powered the shaft through a belt and pulley system, as shown in Fig. 2. Zebra strips were pasted on the shaft that were read by a laser tachometer to determine its speed. The power supplied to the electric motor could be controlled which adjusted the speed of the rotor. The pitch of the blade was measured by placing a tilt sensor (inclinometer) at 30% of the chord length of the blade as it is the position which has the maximum height along the chord and should be parallel to the chord line of the aerofoil.

Fig. 2. Rotor shaft setup.

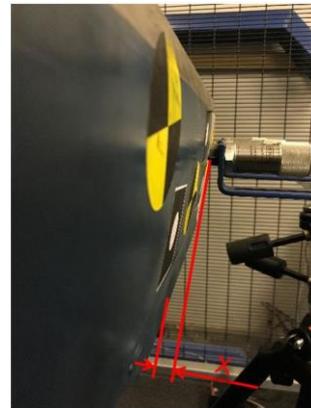
Three WIKA P-30 pressure transducers were attached to a frame to form a radial rake of measurements. The transducers were positioned at radial distances of 67%, 80% and 100% of the rotor radius, i.e. 620mm, 744mm and 930mm (at the tip) from the centre of the rotor. The stand for the rake was then positioned such that the pressure probes were parallel to the blade and perpendicularly placed at a distance X, shown in Fig. 3. Marker X in Fig. 3 was measured from the trailing edge of the blade (the chord line when using zero pitch) to the opening of the WIKA sensor for pressure measurement. Values of X for which data was captured were 20mm and 100mm, producing a total of 6 time-dependent pressure measurements. The setup of pressure transducers are shown in Fig. 3 and Fig. 4.

Fig. 3. Perpendicular distance X.

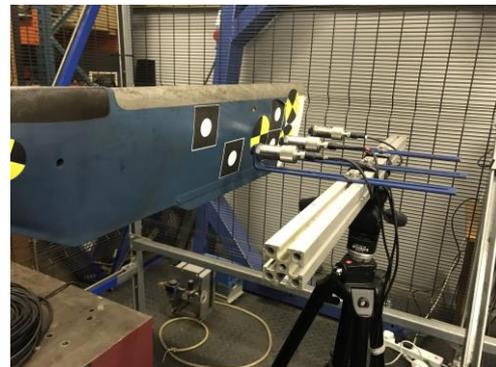
Fig. 4. Transducer positioning.

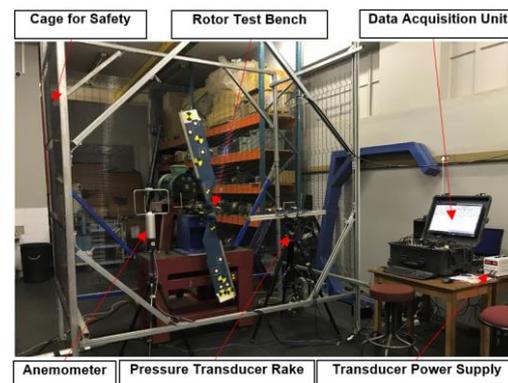
Finally, Fig. 5 depicts the overall setup for the experiments. The power supply used for the transducers and the data acquisition unit which the equipment was wired to for data recording can be seen. The data acquisition unit was set to record at

Fig. 5. Complete experimental setup.

A cage that was constructed around the rotor test bench can be seen in a few of the figures. This was for safety purposes. An anemometer is also seen in the experimental setup which was connected to the data acquisition unit and for which data was recorded during the experiments. The results produced by the anemometer were discarded as it collected data at a maximum output frequency of 32 Hz which was insufficient in capturing any useful transients when the helicopter rotor was ramped up to full speed.

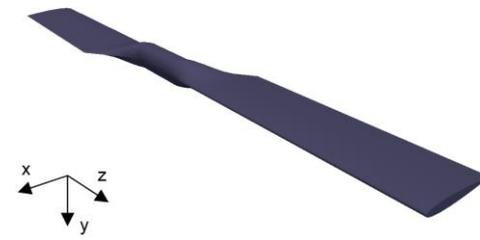
The rotor geometry was defined by following the specifications provided for the tail rotor and using the NACA 0012 airfoil with a 185 mm chord length. Figure 6 portrays the model generated for the healthy rotor. The rotor geometry was simplified from the true geometry to exclude unnecessary details, which include the modelling of the hub region as well as the removal of the trim tab. It is understood that the trim tab affects the aerodynamics of the rotor but it is not within the scope of this investigation to study its effects directly. This study considers the overall effect of blade mistracking which may be affected by trim tab arrangements and can be considered independently in further investigations. The geometries are modelled such that they rotate about the positive y-axis and extend radially into the z-axis at time zero.

Fig. 6. Healthy blade model.

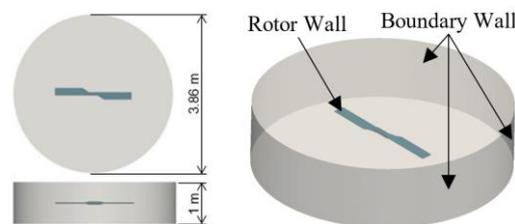
After modelling the rotor geometry, the domain was defined to set the extent of the boundaries wherein the fluid flow will be solved. Figure 8 shows the domain modelled around the rotor blade. The rotor was situated at the centre of a 3.86 m diameter and 1 m high cylinder. The boundary locations were constrained to these dimensions to restrict the computational expense of the simulations. Using the domain extents described in Fig. 8 does have the advantage that it resembles the experimental setup of the rotor in the laboratory as the radial boundaries emulate the restriction of the walls. The top and bottom circles as well as the cylindrical wall which connects the two surfaces make up the boundary wall while the rotor surfaces make up the rotor wall for the prescription of the boundary conditions.

Fig. 8. Model domain boundary locations.

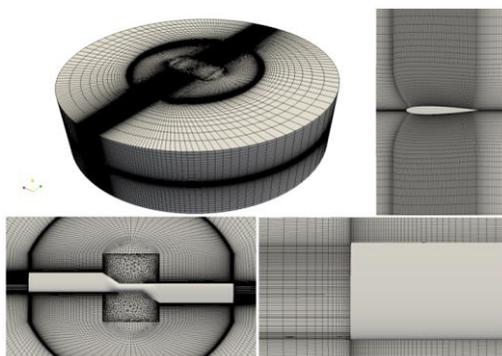
Figure 9 provides a number of screenshots of the mesh that was generated for the healthy rotor where the meshing strategy can be seen. The mesh was dominantly structured and cell heights were linearly stretched such that areas anticipated to have high gradients and require good resolution were biased to have smaller cell heights. The mesh stretched from these regions with the prescribed cell height off the rotor wall to the boundaries reducing the number of cells generated in the mesh and saving computational expense. This ensured that the tip of the blade, its wake and the flow field in the direct vicinity of the rotor blade was resolved well. A mesh of approximately 7.2 million cells was produced.

Fig. 9. Mesh generated for healthy rotor.

Figure 9 reveals that in most regions, the mesh is of good quality with the exception of the centre region

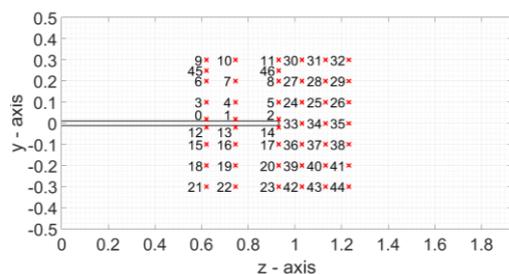
The locations at which pressure and velocity were probed in the field of the rotor are shown in Fig. 10. Probes 0 to 5 correspond to the experimental locations at which data was captured in the field of the blade. Pressures and velocities at these locations were monitored for convergence along with the rotor moments, forces and the residuals of the field variables. These parameters were monitored for steady behaviour which meant that for most of the parameters steady periodic oscillatory behaviour signified convergence as it is a transient analysis. Once convergence was identified, the solution was allowed to develop for a further 4 full revolutions of the rotor to produce converged data for analysis.

Fig. 10. Location of simulation probes in domain.

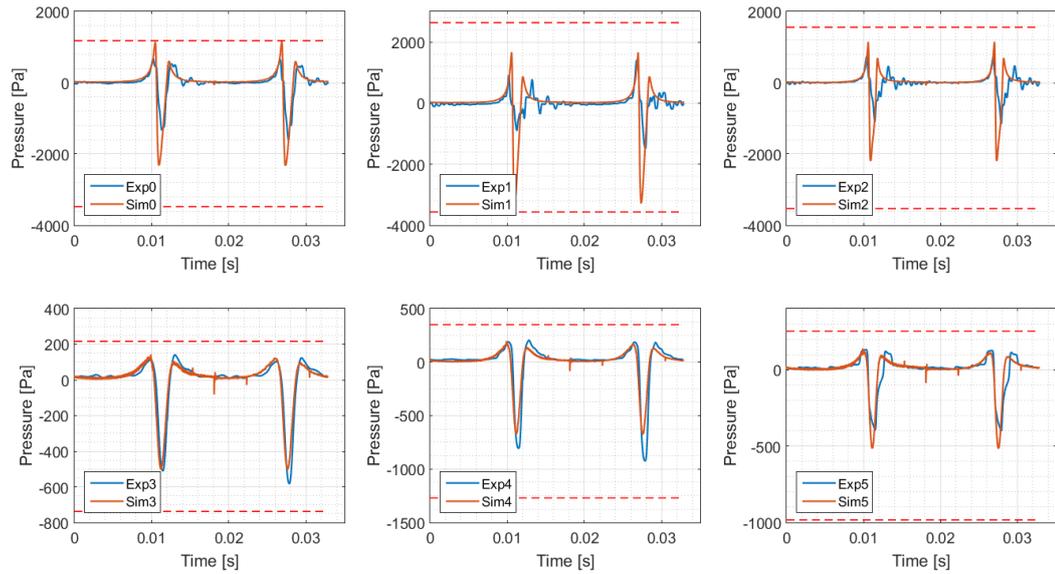
The numerical results produced by the simulations for the healthy rotor blade are compared to the experimental results for validation and to assess the integrity of the simulations in representing the physical phenomena. Validating the simulations also provides a basis on which model-based CM and fault detection can be used to represent actual scenarios. Figure 11 compares the time-synchronously averaged signals over a single revolution for the experiments and the healthy simulation at probes 0 to 5. The maximum and minimum values recorded during the experiments are also plotted as dotted lines.

The simulations predict the crests and the troughs of the pressure profiles at each location well. Probes 3 to 5 appear to match the experiments better than probes 0 to 2. However, experimental probes 0 to 2 feature a larger variance in its peak values which is evidenced by the difference between the maximums, minimums and averaged signals at each probe as well as the presence of the fluctuations inherent in the averaged signals, specifically after the blade had passed which may indicate the presence of trailing vortices and other transients disturbing the flow near the blade and in its wake. These fluctuations are not well represented by the simulated probes which are most likely due to the limitation in using URANS modelling as it would not be able to model disturbances at these frequencies. Even though these discrepancies are present, the numerical results at these closer locations are still within reason of modelling the pressures at these locations as they represent the experimental signals appropriately and are within their maximum and minimum bounds. A visible distinction is also seen at probes 2 and 5 since these probes are situated at the tip of the rotor. Again, disturbances affect the profile of the experimental pressures but the simulated signal of probes 2 and 5 resolve the drop in the pressure peaks at these locations in comparison to the peaks at probes 1 and 4. The numerical results at probes 3 and 4 resemble the experimental results impeccably. It is compelling to see that the numerical results produce troughs which are near identical for each blade passing. A static analysis of the experimental test bench, in which each of the blade tracks was measured with respect to a fixed location, found that the tips were 15

Fig. 11. Comparison of experimental and numerical pressure profiles.

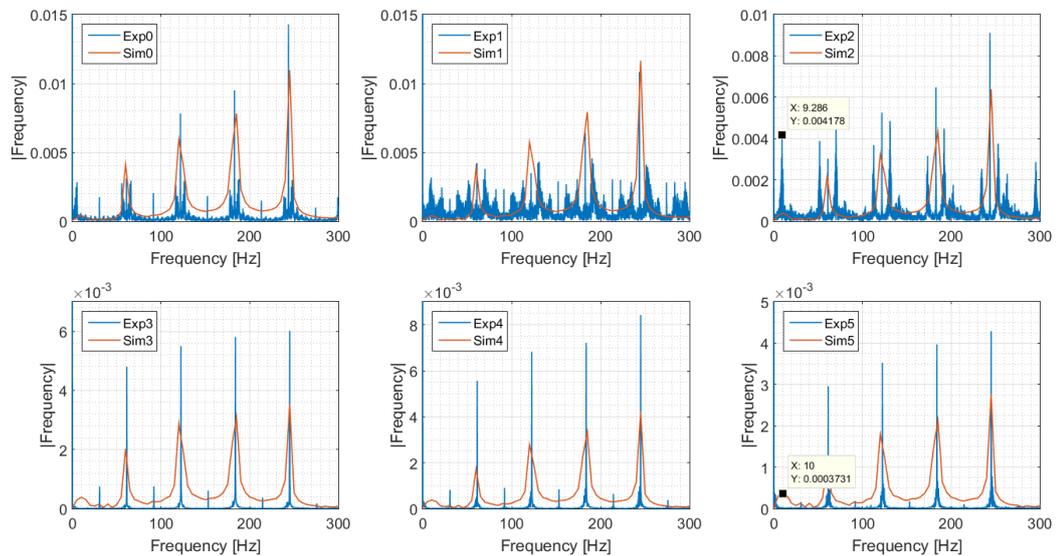
Fig. 12. Comparison of experimental and numerical frequency content.

Figure 12 compares the frequencies for the experiments and the healthy simulations at probes 0 to 5. Be aware that the numerical frequency

amplitudes had to be scaled for the comparison so it is only the peak frequency components that are of interest. The comparisons of the frequencies show that all of the numerical probes predict the blade pass frequency (≈ 61 Hz) and all of its harmonics well correlating with the experiments. Unlike the experiments, the numerical probes do not observe frequencies at the rotational frequency (≈ 30.5 Hz) which describes the experimental blade mismatch while the healthy simulation had near-identical profiles for each blade passing thus identifying the blade pass frequency only.

Note that the numerical results predict a low-frequency component at approximately 10 Hz but do not display any sidebands like the experimental work. [Xu *et al.* \(2002\)](#) describe this low-frequency component to be a result of aerodynamic delay which

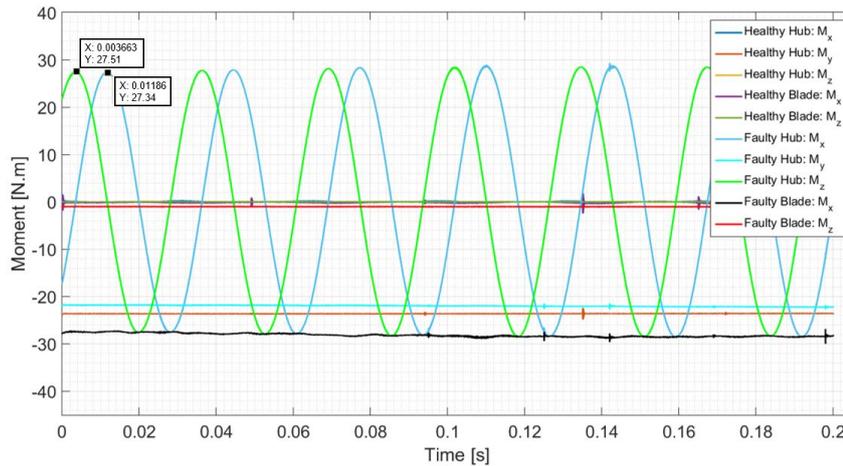
Fig. 13. Comparison of healthy and faulty rotor moments for hub and blade reference frames.

Comparing the results for the faulty blade at the hub, considerable differences are observed. The x and z hub components fluctuate between high moment values. These two components are phase-shifted by a 90° rotation of the blade which is clearly based on the time instances at which the measurements align with the hub coordinate system. It is also intriguing to note the minor decrease in the y-component for the faulty rotor at the hub. The transformed x and z-components for the faulty rotor show that in a reference frame which follows the blade, there is a small negative z moment and a large negative x moment. Considering the imposed fault, these conclusions are logical as the lift of the two mistracked blades is enforced in two different planes causing a twist about the x-axis.

Transforming each of these signals into the frequency domain reveals that there are no other noteworthy frequency components apart from large amplitude increases in the x and z hub components at the frequency of the rotational speed. This is apparent by simply observing the trends shown in Fig. 13.

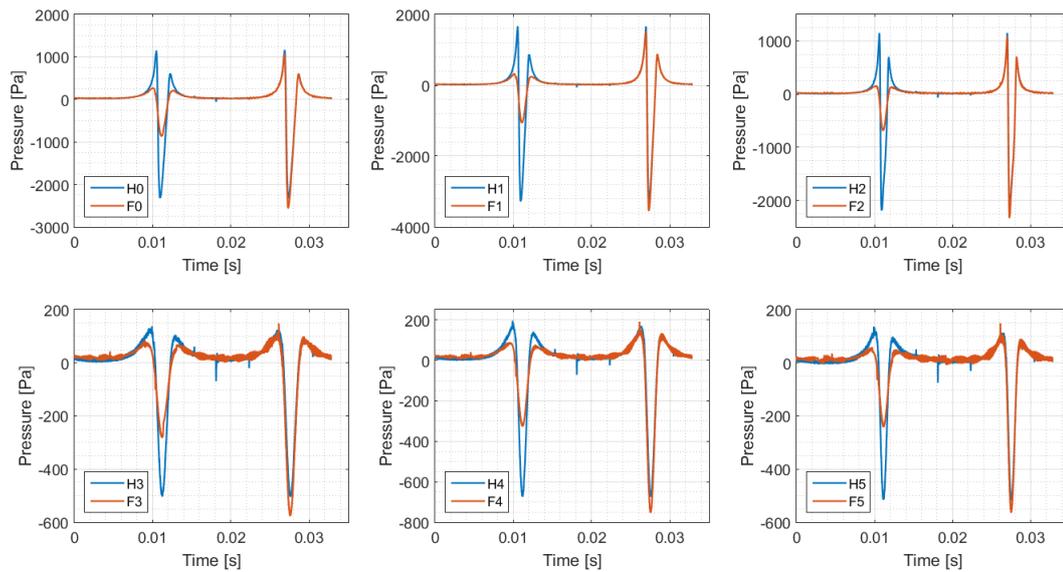
Fig. 14. Comparison of healthy and faulty pressure profiles.

faulty blade passes. A reduction (as opposed to an increase) in the trough is expected since all of the probes pictured are situated in the positive y-axis while the blade was deflected into the negative y-axis. This phenomenon clearly demonstrates that a rotor which is out of track is expressed as non-symmetric troughs in the time-domain. This is substantiated by the experimental results of Section 4.1 whose pressures were non-symmetric having been recorded for a rotor which was out of track. One should also note the phenomenon of the slight amplitude increase for the blade that tracks perfectly on the faulty rotor in comparison to the stable symmetric troughs for the healthy rotor. This might be caused by the perfect blade rotating through flow that is more orderly than when it passes through the other blades wake, causing an adverse pressure gradient and disturbing the flow more.

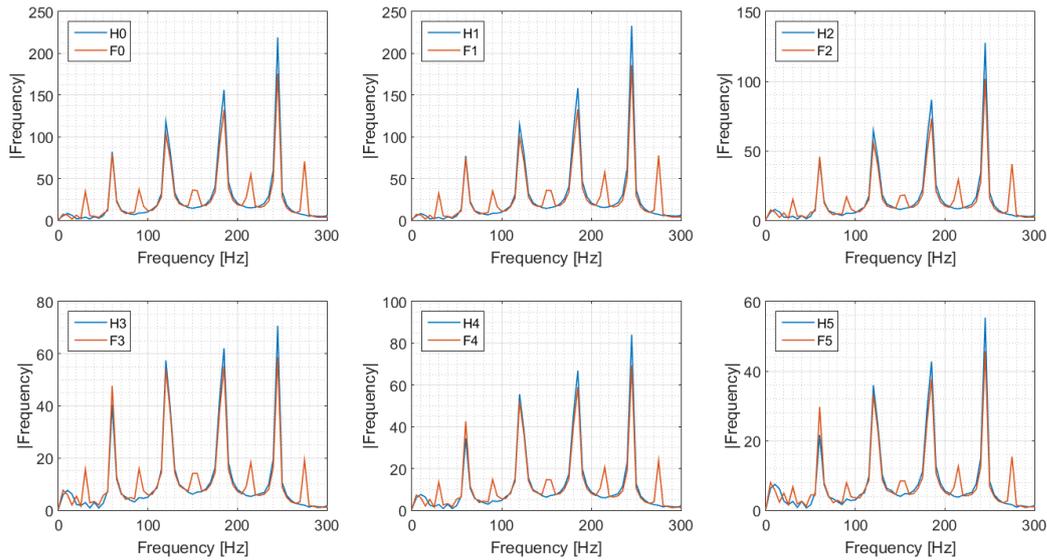
Figure 15 compares the frequencies for the healthy and faulty simulations at probes 0 to 5. It is clear that the fault arises as increases in the amplitudes of the frequencies at the rotational frequency of the rotor (1/rev frequency). This is again supported by the results produced in Section 4.1 since frequencies at the rotational frequency were observed for the out of track rotor. Comparing the 1/rev frequency amplitudes exhibited at each probe location, probes 0 and 1 have similar amplitudes and are the highest amongst all the probes. Probes 3 and 4 also reproduce similar amplitudes but are smaller than probes 0 and 1 since they are located further away from the blade. Probes 2 and 5 see major reductions in their amplitudes in comparison to their rake counterparts and can again be attributed to the loss in pressure due to tip vortices. All probes for both rotor configurations display high-frequency amplitudes at the blade pass frequency and its harmonics. The pressure signals for the faulty blades appear to decrease the amplitudes of the harmonics at these frequencies slightly.

Fig. 15. Comparison of healthy and faulty frequency content.

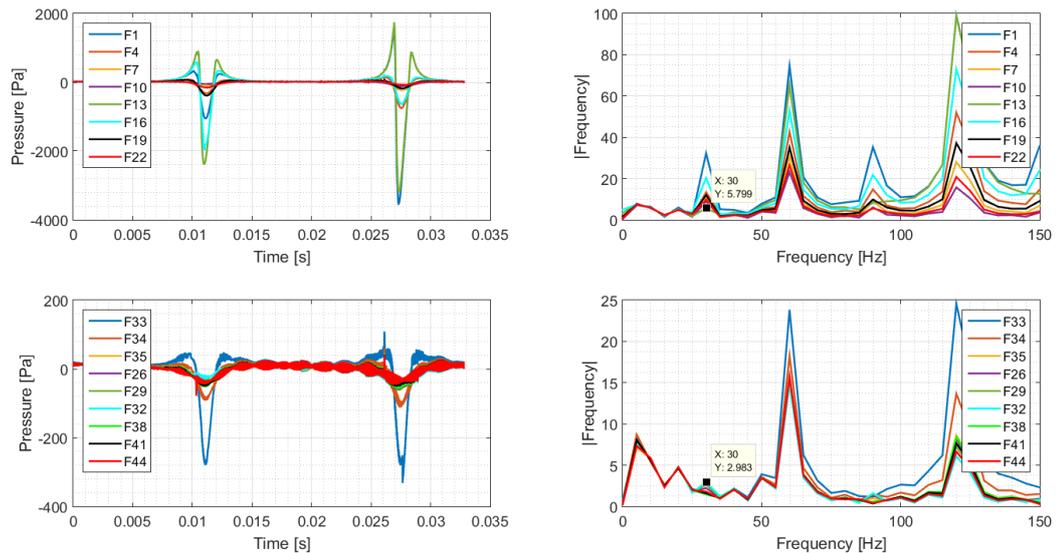
Fig. 16. Comparisons of faulty pressure profiles and frequencies at different probe locations.

From previous sections pressure probes 0 to 2 portrayed higher peak values in comparison to probes 3 to 5 which intuitively makes sense. Also, various results illustrated the inefficiency of the probes situated at the rotor tip in representing the pressure amplitudes found by the probes within the blade radius. This implies that probes at 67% and 80% of the radius predicted the anomaly better. Referring to Fig. 10 for the probe locations, pressures probed at 80% of the blade radius will be compared to assess the degradation in the fault detection as one moves perpendicularly away from the rotor blade (probes 10, 7, 4, 1, 13, 16, 19 and 22). Also, probes situated in the plane of the rotor but extended past its radius (probes 33, 34 and 35) shall be compared as well as pressures at locations far away from the blade radius and out of the rotor plane (32, 29, 26, 38, 41 and 44). Figure 16 shows the results of the pressures at each of these locations and its respective frequency transformations for the faulty rotor only.

Comparing the pressure profiles of the probes recorded in line at 80% of the faulty rotor radius expresses the decay in the troughs as the probes move perpendicularly away from the rotor blade. The trough representing the perfect blade of the faulty rotor deteriorates with minimum values of 3500, 752, 230 and 110 Pa for probes 1, 4, 7 and 10 respectively. This shows that at a perpendicular distance of 0.3 m away from the rotor blade, a pressure probe would need to detect a pressure fluctuation smaller than 110 Pa which could very well be lost to external interactions and noise in practical applications. Nevertheless, the numerical results show that even with the smaller peak values, the frequencies at these pressure probes demonstrate that they are still capable of establishing the existence of the asymmetry since there are peaks at the rotational frequency of the blade.

Comparison of the results for all of the probes which extend further than the radius of the rotor signify inadequate fault detection. Not much can be distinguished in the pressure profiles plotted per rotation which is verified in the frequencies they produce. These probes do not identify the rotational frequency of the rotor well enough.

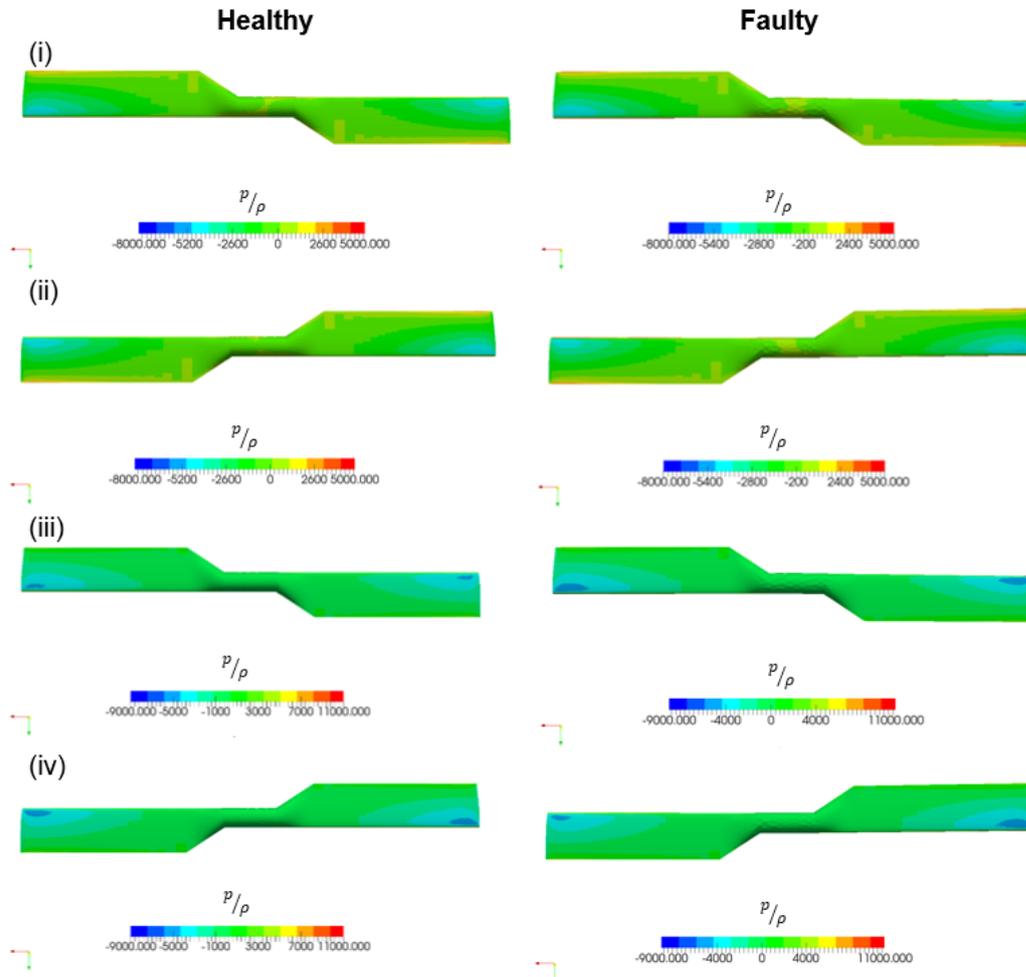
Fig. 17. Comparison of healthy and faulty pressures over the surface of the blade.

In all of the healthy instances, good symmetry is observed in the surface pressures between each of the blades. On the contrary, each of the faulty rotors show some irregularities between the blades. Figure 17 (i) shows a larger drop in pressure near the leading edge at the tip of the faulty blade for the specific pressure range. Although a vast difference can be seen between the healthy and faulty surface pressures for (iii), it is difficult to identify the fault by only comparing the blades of the faulty rotor as done for
